Comprehensive Groundwater Protection Evaluation
for the South San Francisco Bay Basins

Figure 28: Known Potential
Vertical Conduits

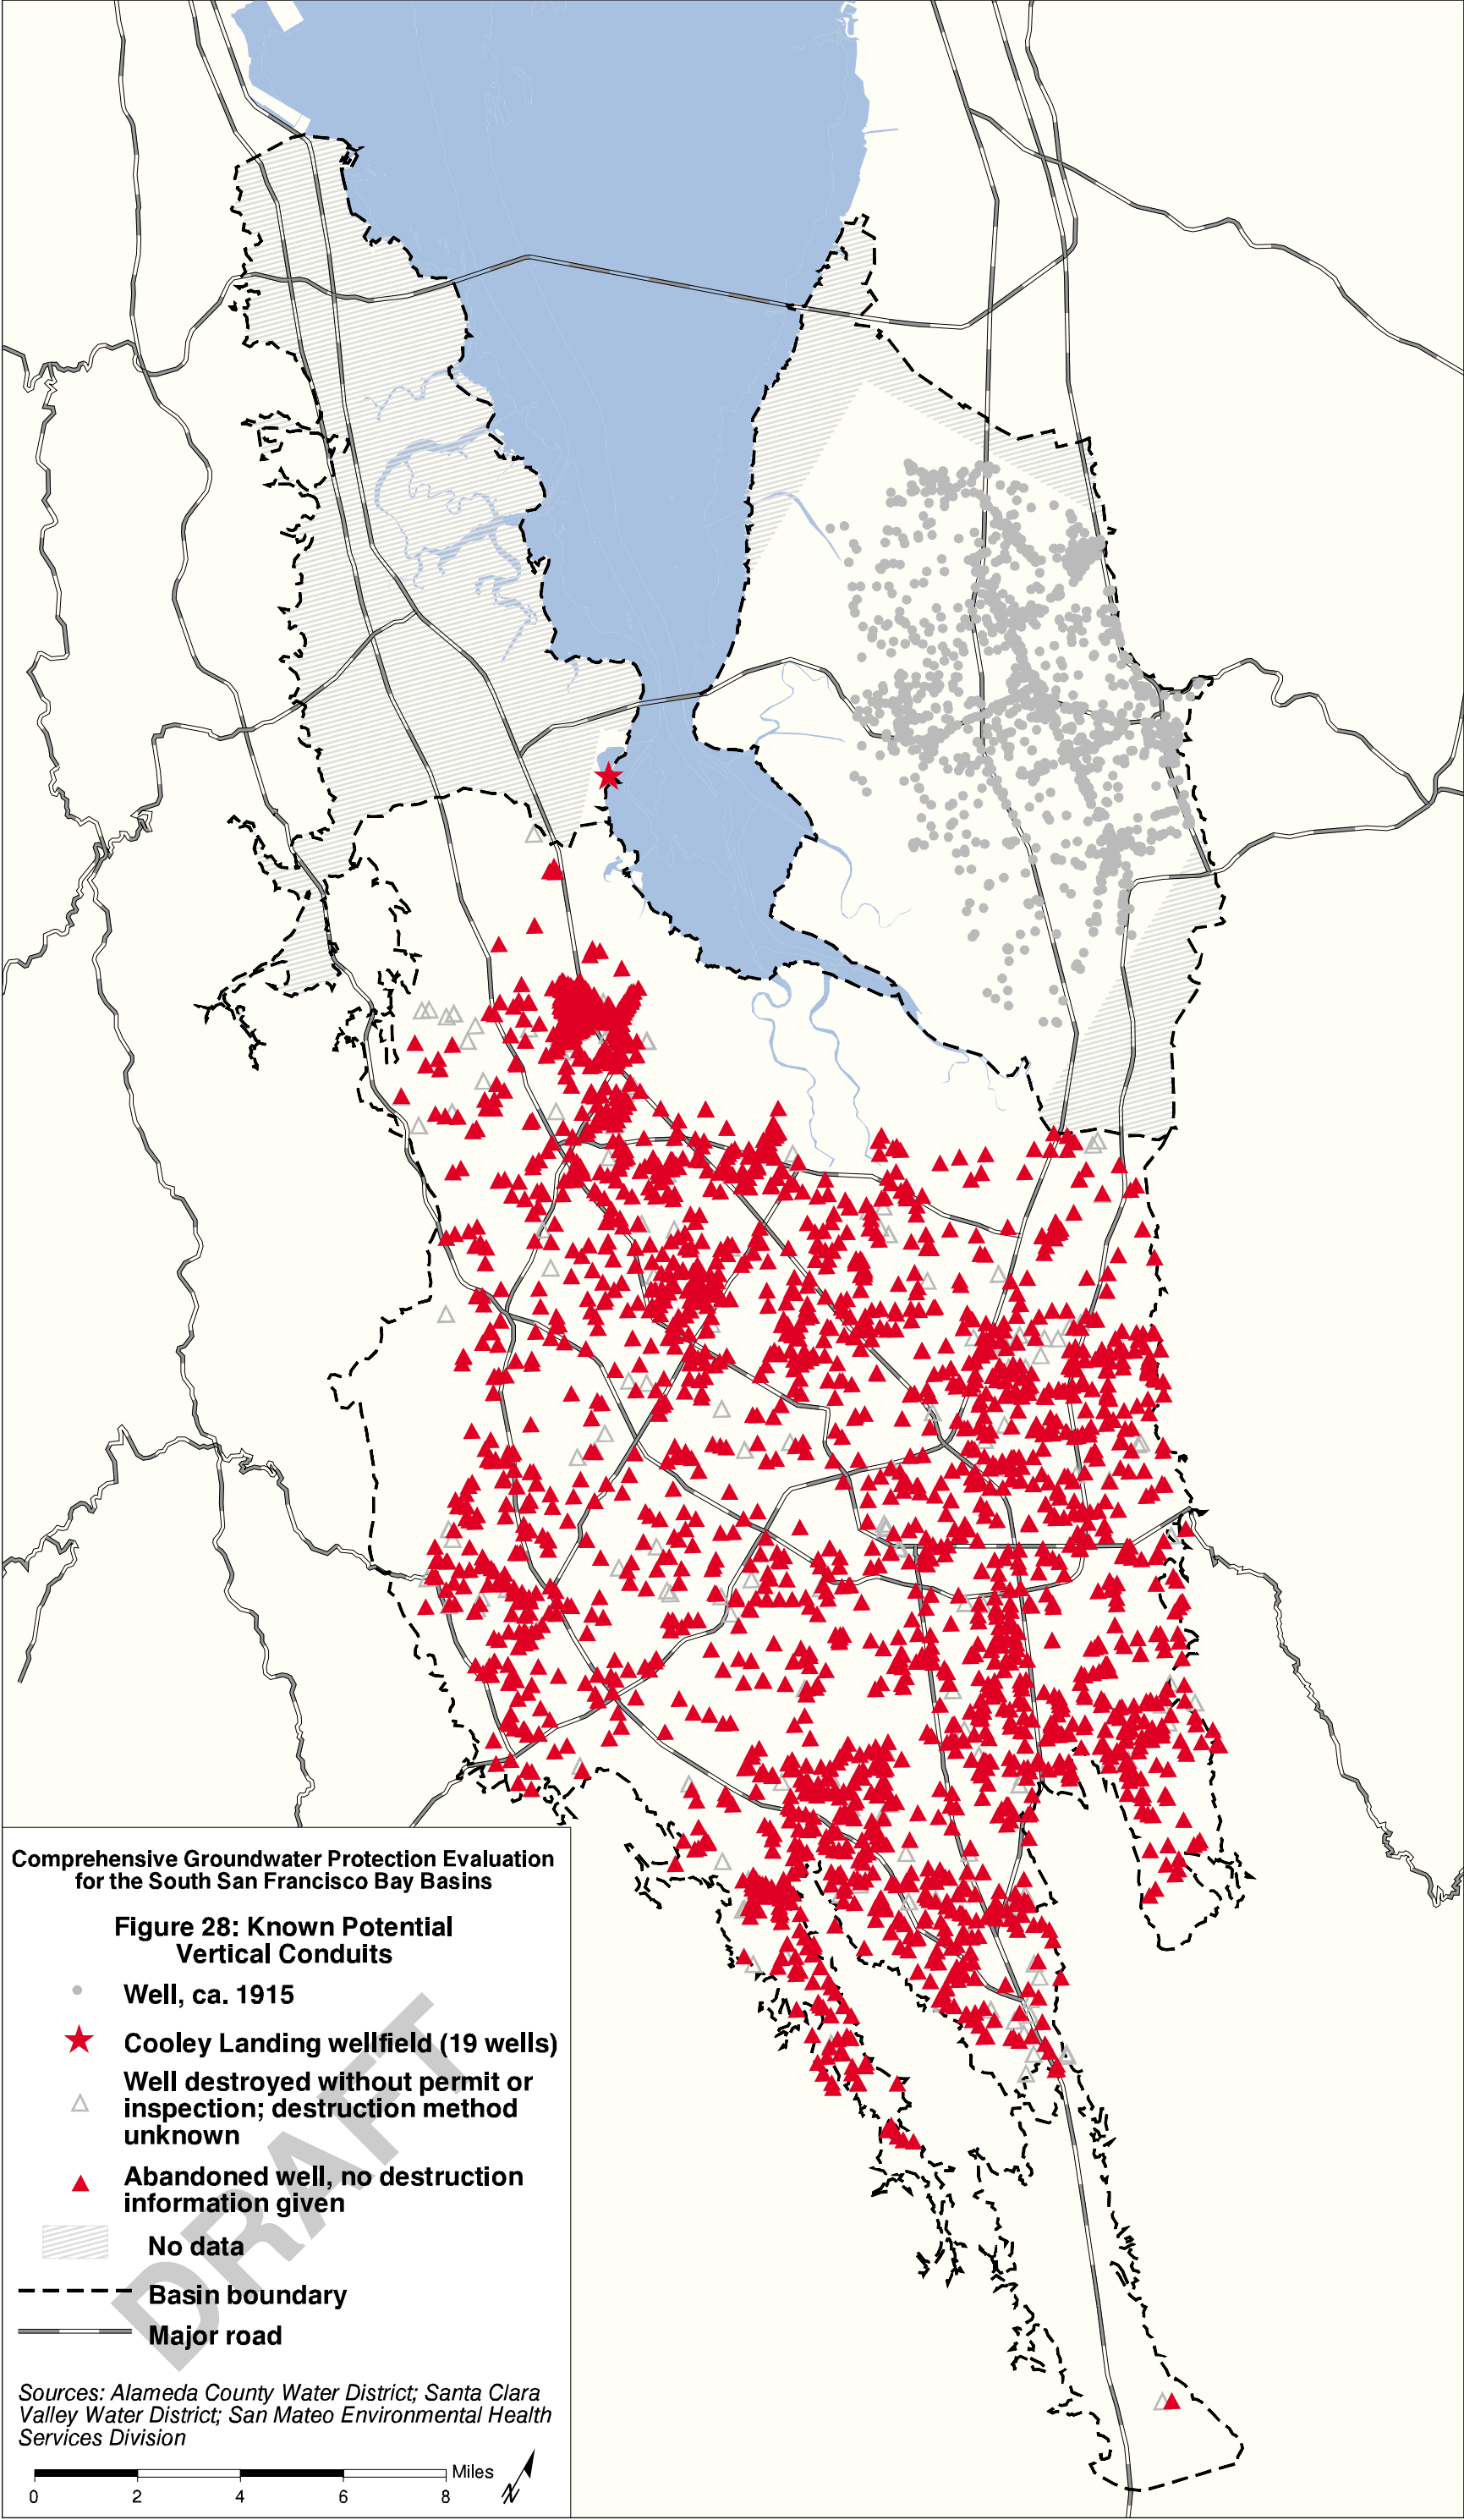
- Well, ca. 1915
- Cooley Landing wellfield (19 wells)
- Well destroyed without permit or inspection; destruction method unknown
- Abandoned well, no destruction information given
- No data
- Basin boundary
- Major road
